FABRICATION AND VERIFICATION TESTING OF ETM 30 CM DIAMETER ION THRUSTERS

FINAL REPORT

APRIL 1977

ION PHYSICS DEPARTMENT STAFF
HUGHES RESEARCH LABORATORIES
A DIVISION OF HUGHES AIRCRAFT COMPANY
3011 MALIBU CANYON ROAD
MALIBU, CALIFORNIA 90265

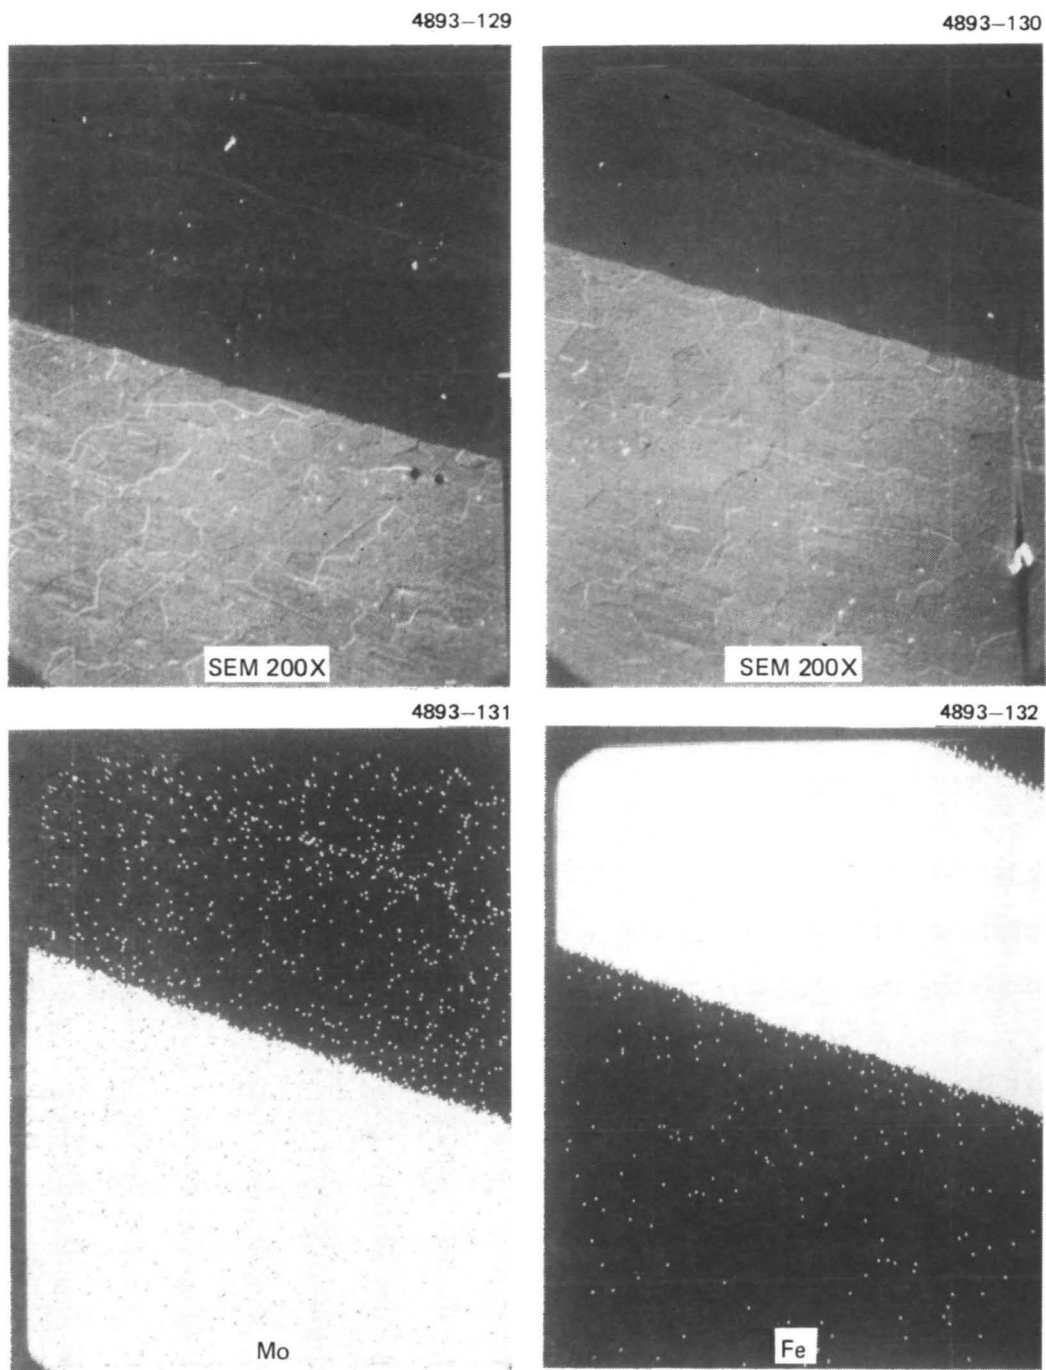
Figure A-50. SEM photo and K α X-ray analysis of downstream keeper coating.

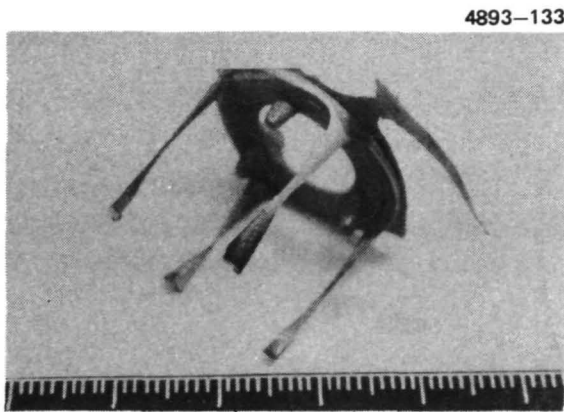
Figure A-51. Baffle support.

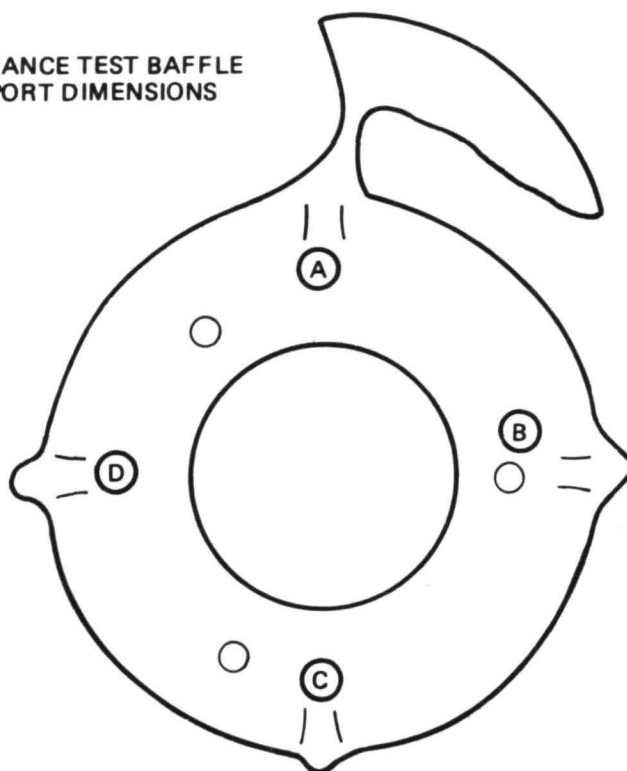
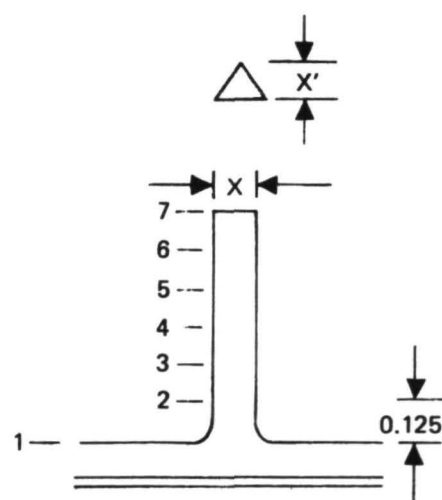
Figure A-52. Endurance test baffle support dimensions.

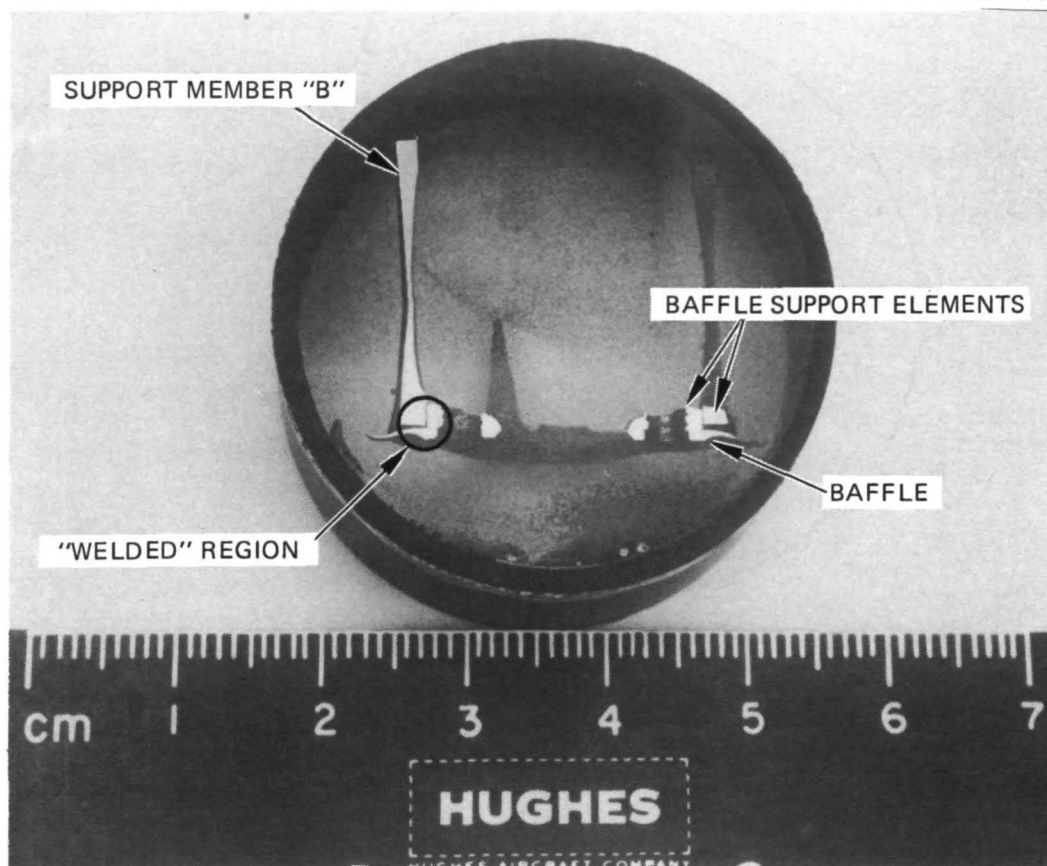
Having documented the support structure in this manner, a second attempt at removing the baffle fastening screws proved successful, but the baffle still could not be removed and was found to be securely "welded" in place. The assembly was then sectioned as shown in Fig. A-53, and the "welded" region was identified as a nickel "brazed" by means of the E-beam microprobe analysis shown in Fig. A-54. It is thought that the nickel coating placed on the mild steel parts to prevent oxidation is responsible for the "welding" of these parts. It is

Figure A-53. Magnified view of baffle support cross section.

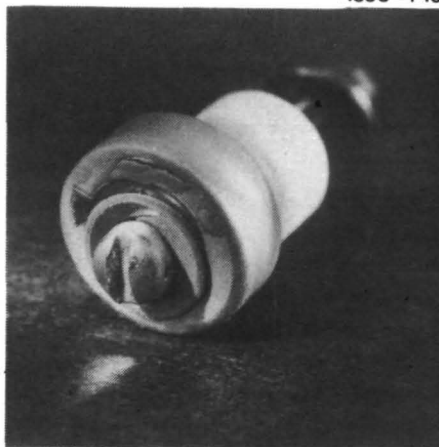
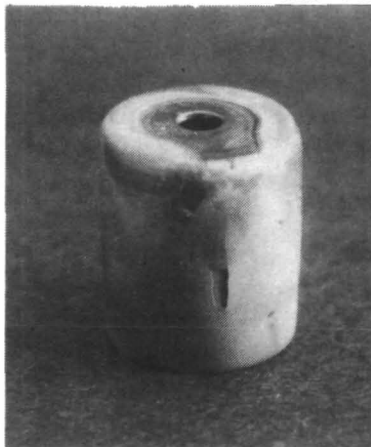
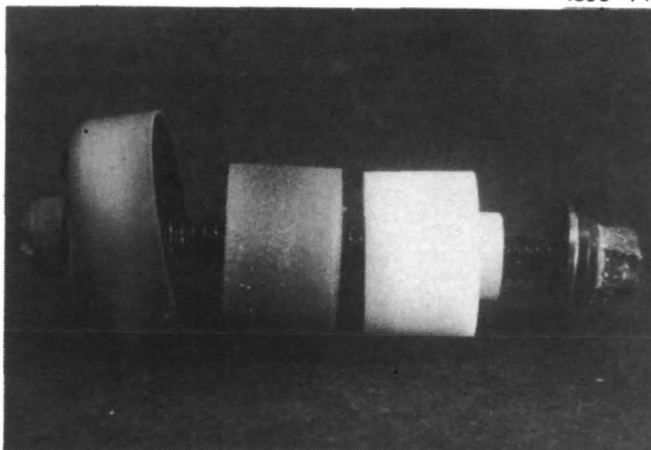
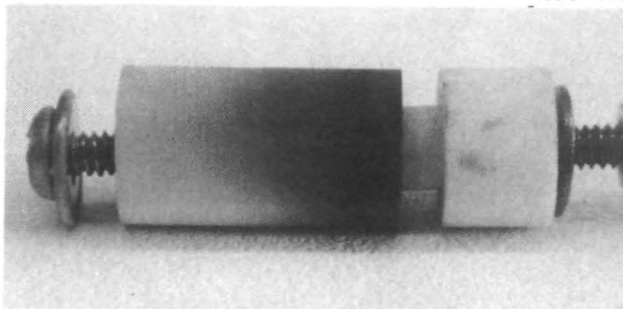
Other observations that were made in examining this assembly are documented in Figs. A-55 and A-56. Deposition on the keeper support insulator and shield and on the baffle coil termination insulators and shield is shown in Fig. A-55. This deposition did not cause any problems in the test, but suggests a need for double shielding of the insulators and surface treatment on the shields to prevent formations of sizeable "flakes." Baffle coil termination will be made outside the discharge chamber in subsequent thrusters. A portion of the flake removed from the keeper insulator (Fig. A-55(b)) was 0.0015 in. thick (0.004 cm) and would be extremely hazardous to thruster operability if it lodged between the ion optics grid. Figure A-56 shows the cathode subassembly as it appeared after removal (the threaded rods seen were used to facilitate handling). The discussion of cathode condition is deferred to a later section; however, the erosion on the cathode radiator that was visible in Figs. A-43 and A-44 can be seen more readily here. This damage is considered of little importance to either the operation or lifetime of the cathode.

Figure A-55. Cathode keeper supports and baffle terminal supports.

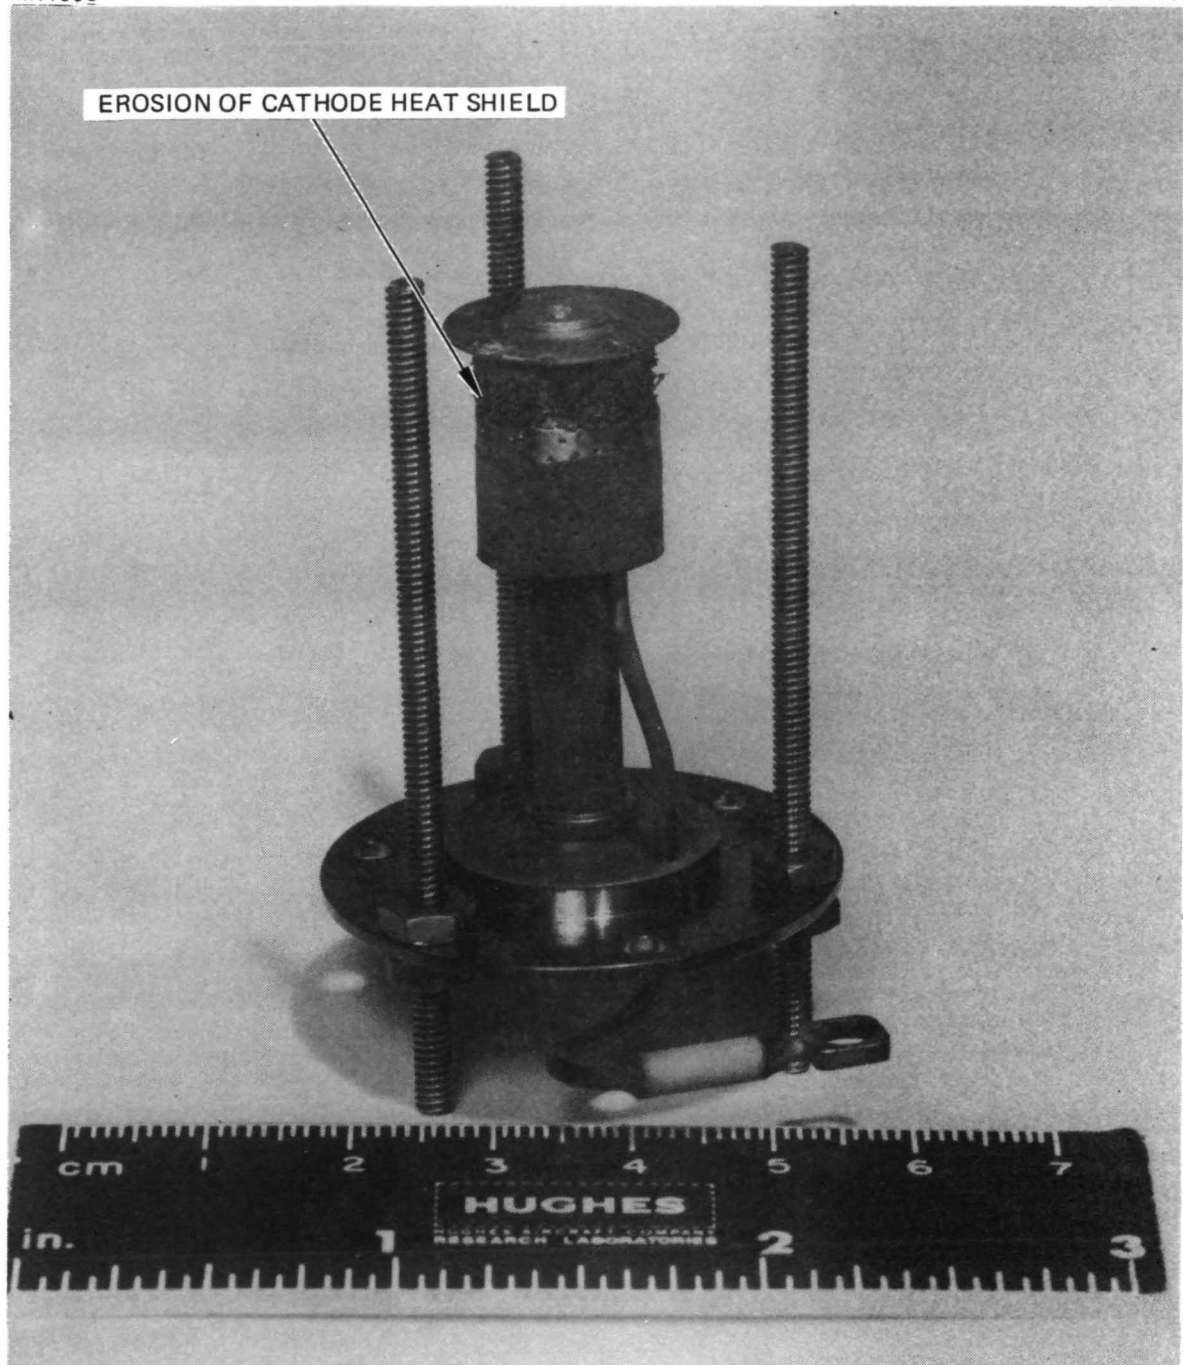
Figure A-56. Thruster cathode.

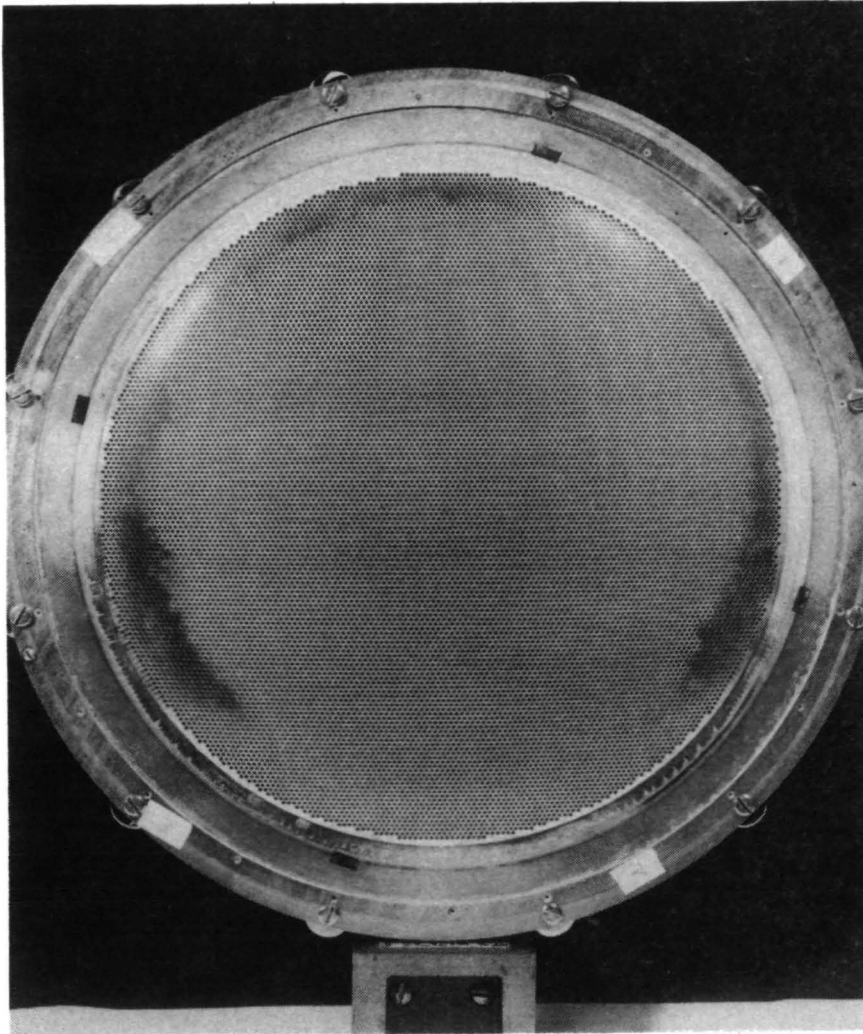
Figure A-58. Ion optics assembly SN648 downstream view before test.

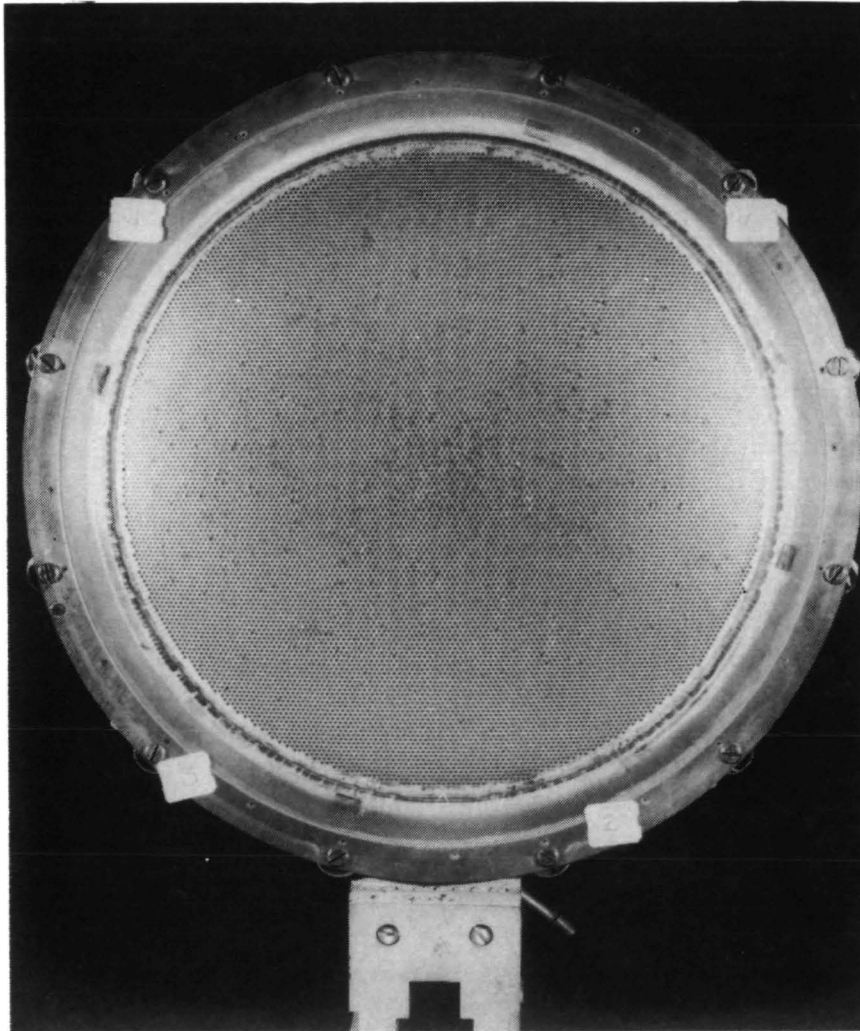
Figure A-59. Ion optics assembly SN648 downstream view after test.

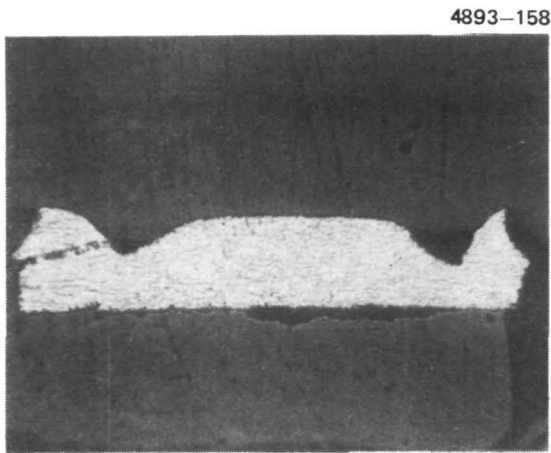
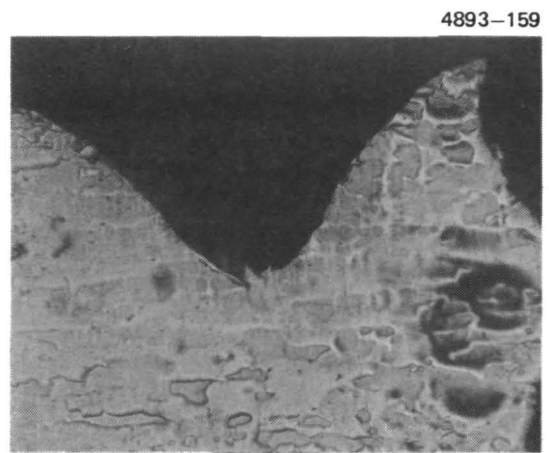
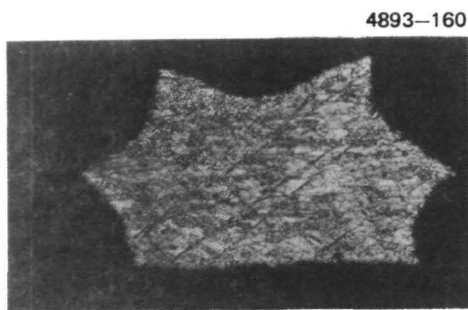
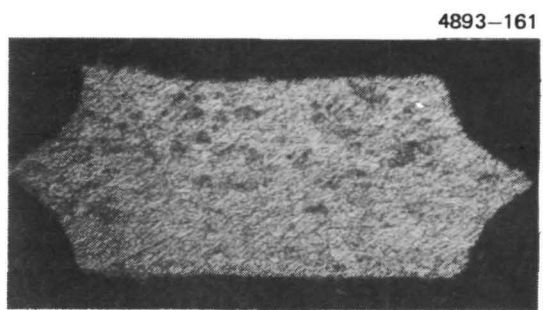
Figure A-69. Selected cross sections of accel electrode.

The depth of the charge exchange erosion was investigated carefully, both by microscopic examination and by cross-sectioning segments of the electrode taken from the center and the edge of the grid. The "pits" are seen as triangles (Fig. A-68) in the center of the web of material common to any three apertures. These pits vary but are usually almost conical in shape with a very small cross section at the deepest point. They vary in depth from a maximum of 0.013 in. (0.033 cm) near the center to being immeasurable near the edge. The pits are connected by grooves, which are a maximum of 0.006 in. (0.015 cm) deep at the mid-point between pits. The depth and shape of the pits and grooves eroded by charge exchange ions appears to also be influenced by their proximity to defocused beam ion damage. In areas where there is extensive ion machining damage, the pits and grooves are shallower and broader. Figure A-69 shows some selected cross-sections of the accelerator electrode near the center and the edge. The difference in the views shown reflects the location and angle of the cut through the material. The views shown as Fig. A-69(a) and (b) represent a cut along the groove and through the pits, the depth of the pit shown being approximately 0.012 in. (0.030 cm). It is thought that the sample in (b) has been polished to nearly pass through the center of the pit. A survey of pit depth was made using a microscope at high magnification (1000X) and measuring the travel required to focus on the bottom of the pit as compared to focusing on the undamaged edge. A plot of representative pit depth variation is shown in Fig. A-70.

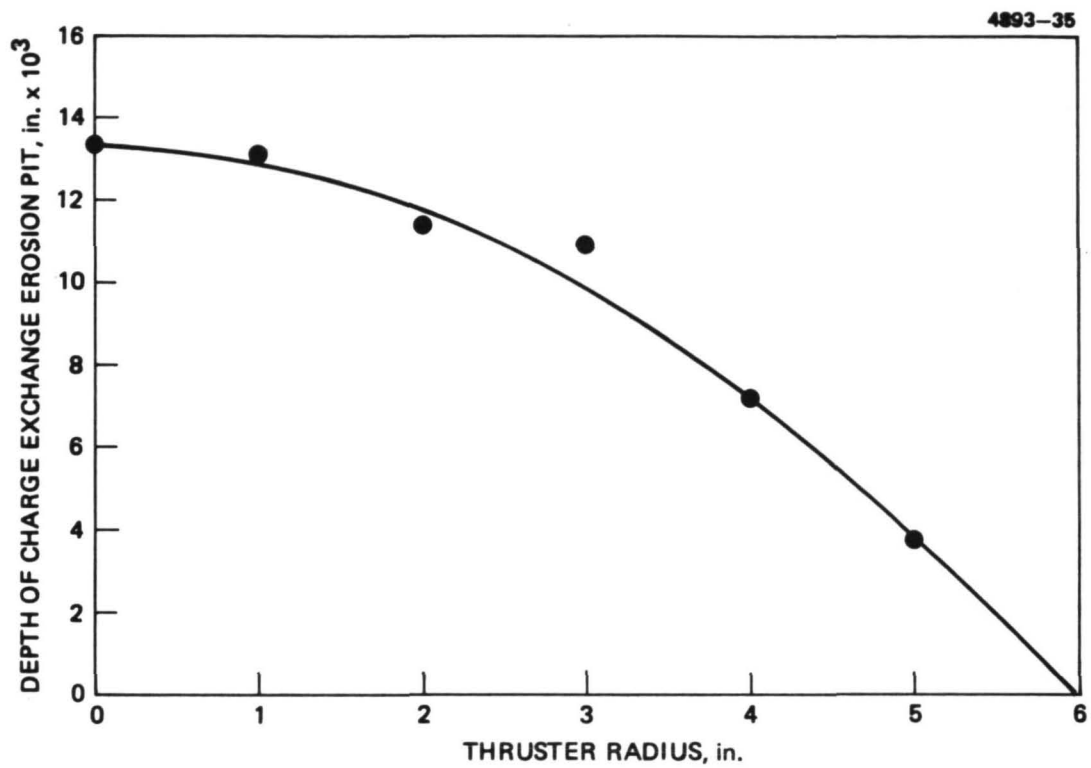
Figure A-70. Depth of charge exchange ion erosion pits as a function of thruster radius on accelerator grid SN648 after 10,000 hour endurance test.

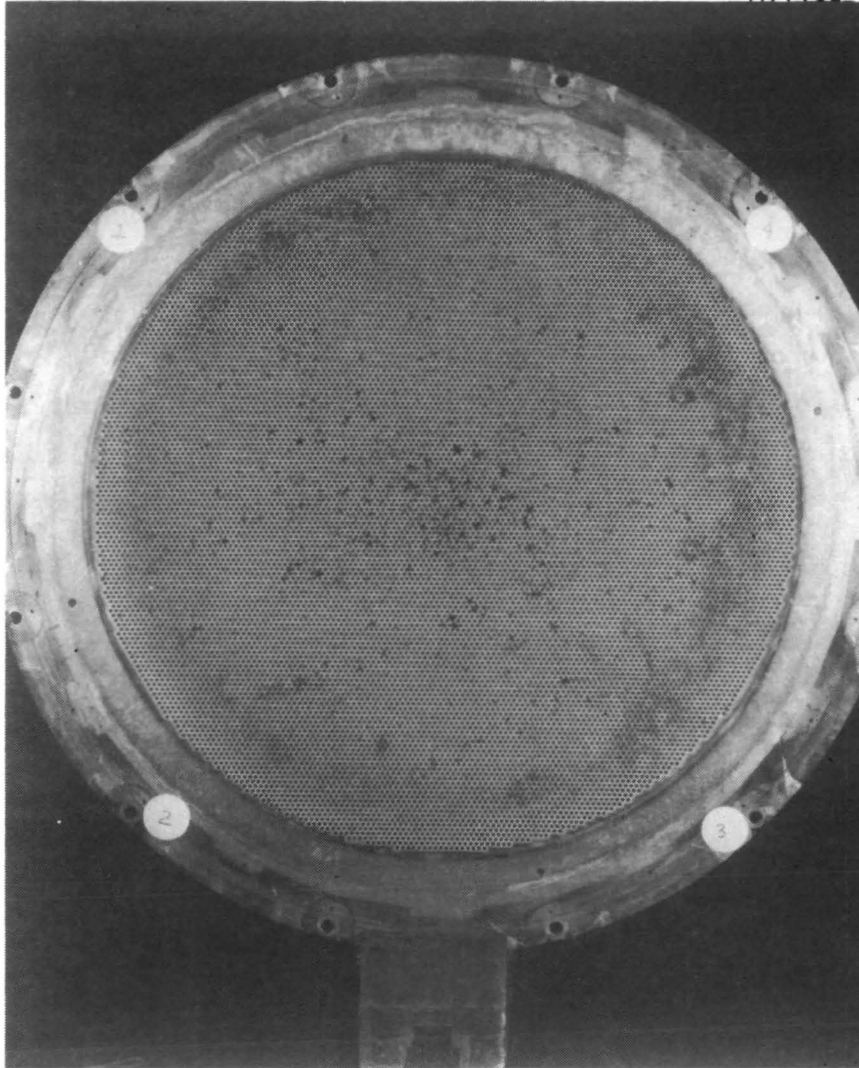
Photographs of the upstream surface of the accelerator are shown in Figs. A-71 through A-75. Careful examination of these pictures reveals several features that have been magnified and included in Fig. A-76. View (a) shows an area that is relatively undamaged but has a "matte" finish that may be the result of low energy ion erosion. Figure A-76(b) shows a typical area in which deflected beam ion erosion has occurred causing "scythe" shaped markings on the grids. This type of damage is rather widespread and, in areas where flakes remained on the screen grid for long time periods, the damage progresses as shown in view (d). View (c) is rather unusual in that the small triangular areas seen in the location that is usually occupied by charge exchange ion erosion pits on the downstream surface is actually a deposition here on the upstream surface. In addition, the edges of the apertures seen in view (c) appear rounded in a chamfered fashion, which is not typical of most other areas on the electrode. No explanation can be offered for the wear seen in view (c). In considering the relatively large number of high voltage overload recycles which occurred during the test, it was thought that arc damage might be distinctly visible on the upstream surface of the accelerator electrode. It has not been possible to identify any damage seen on this electrode with the appearance of damage that is seen when grids are purposely short circuited and the shorting material is then removed by capacitive discharge. This statement does not imply that such damage did not occur, but only that it cannot be conclusively identified.

Figure A-71. Accel after test, upstream side.

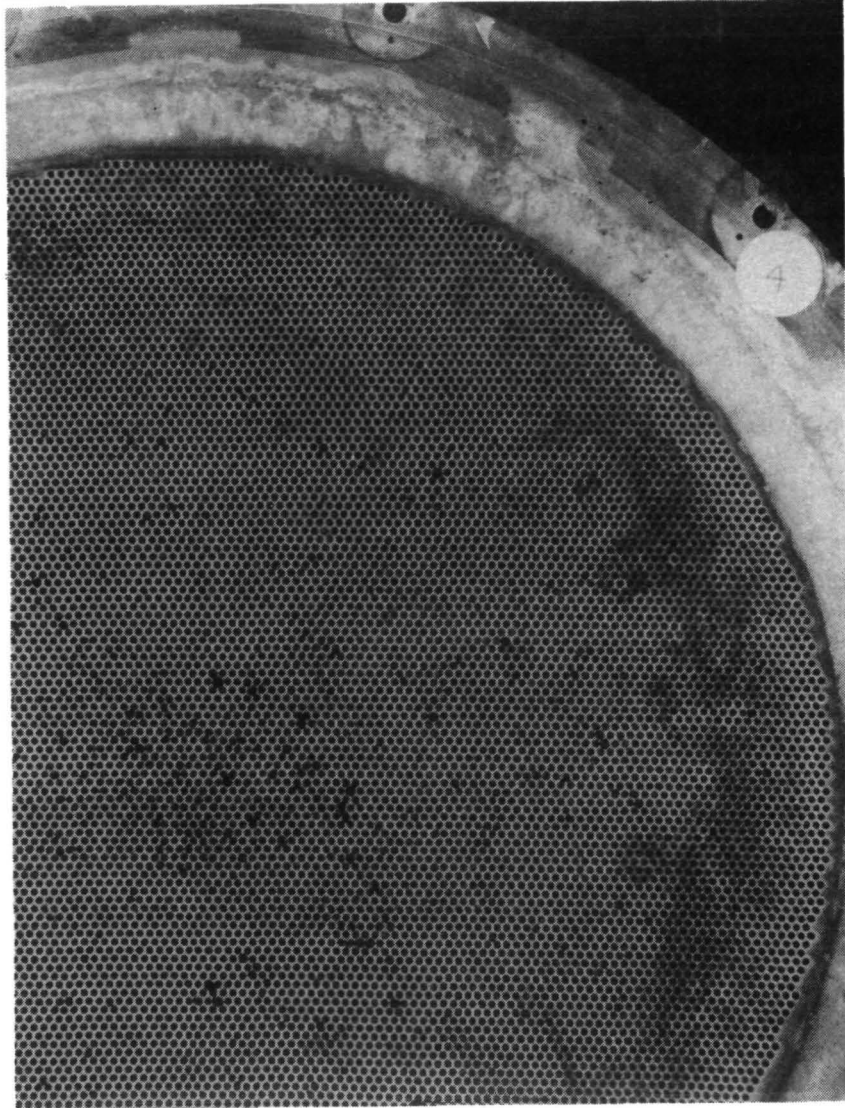
Figure A-75. Accel after test, upstream side.

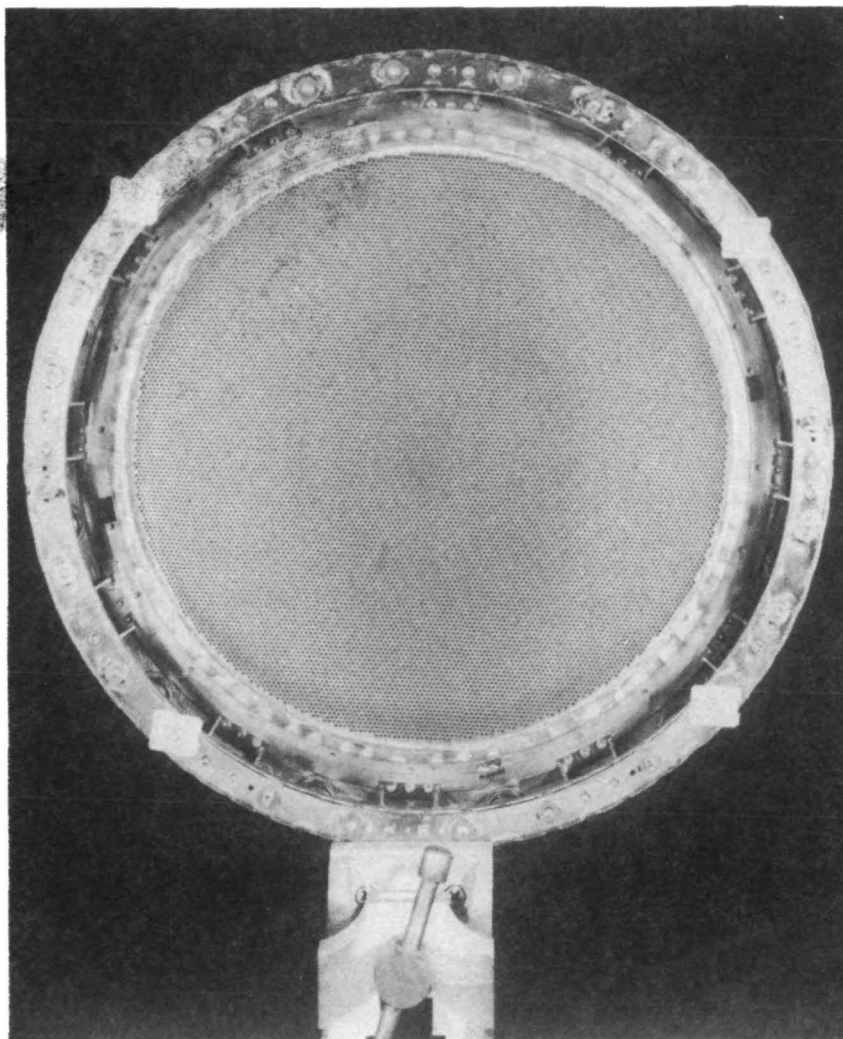
The screen grid electrode has not in the past been of great concern as a factor limiting thruster lifetime. It will be seen in the following paragraphs that appreciable concern is justified. Proceeding in the same manner as above for the accelerator electrode, Figs. A-77 through A-86 compare photographs of the upstream surface of the screen grid before and after testing. It is difficult to detect any differences in the appearance of the screen grid. There appears to be a slight rounding of the aperture edges as seen in views (a) and (b) of the magnified photographs shown in Fig. A-87. These views are representative of the appearance of the center of the electrode, while view (e) shows that such

Figure A-78. Screen electrode, after test.

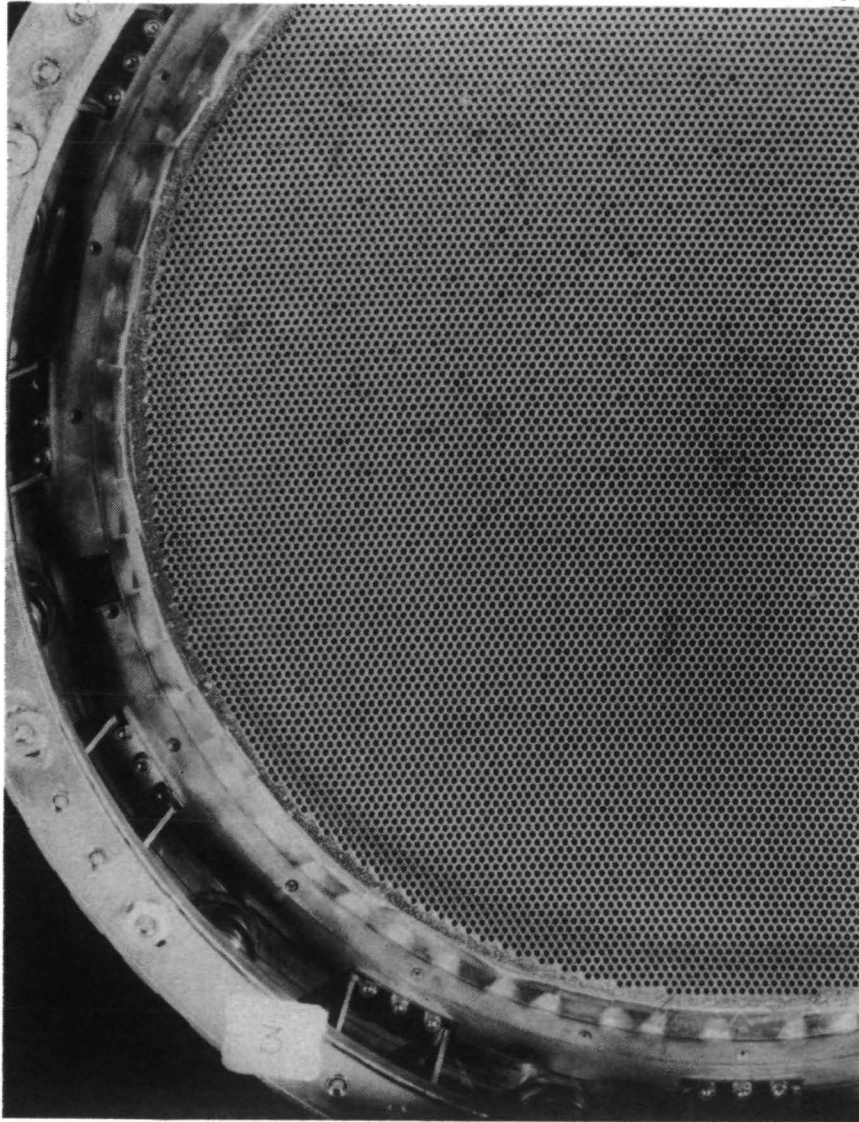
Figure A-84. Screen electrode, after test.

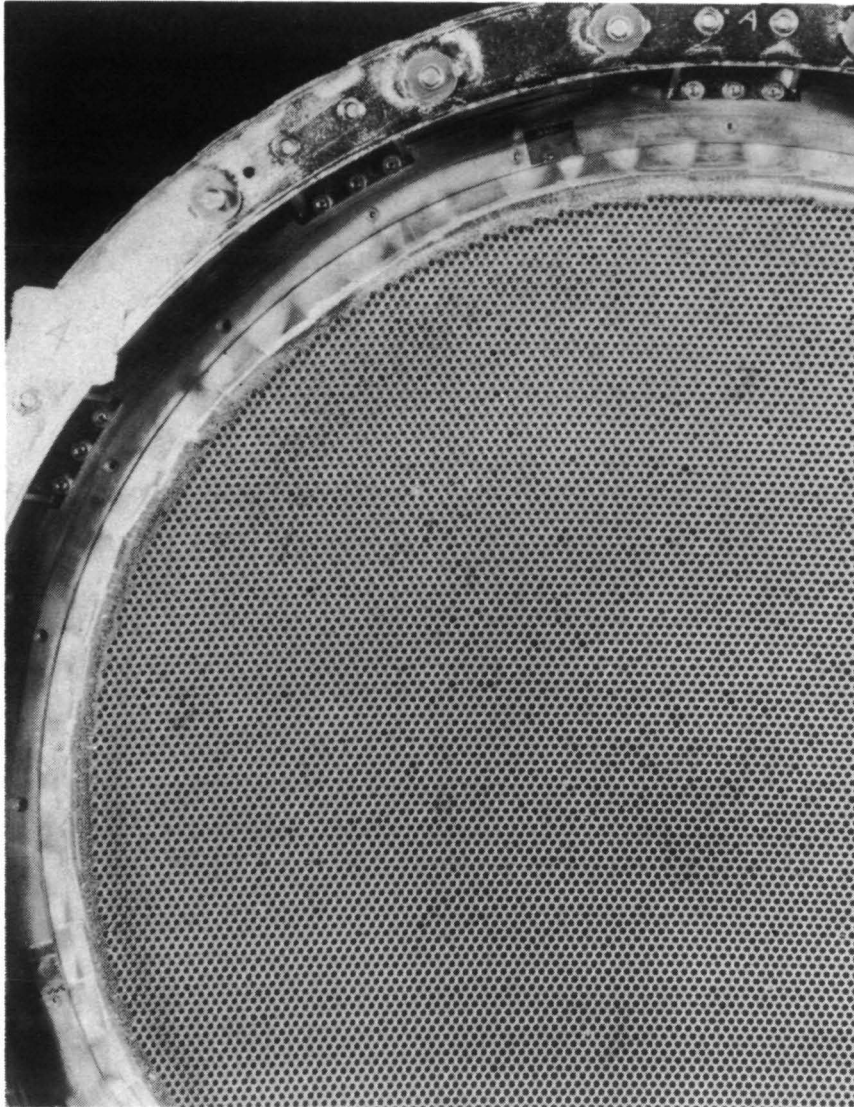
Figure A-86. Screen electrode, after test.

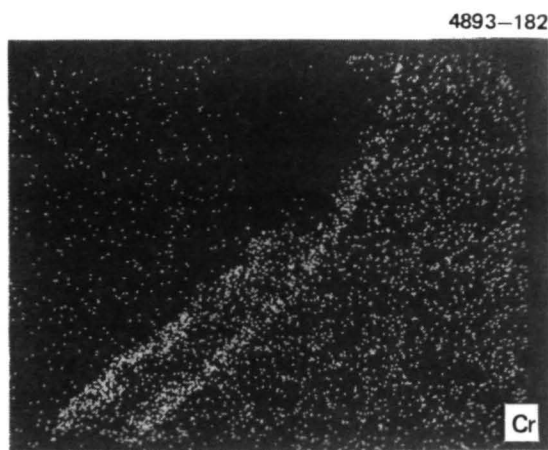
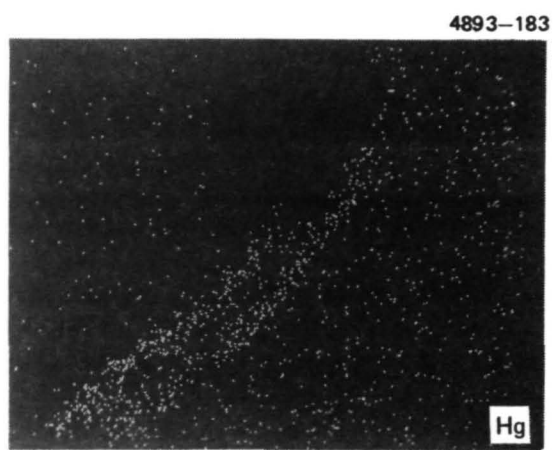
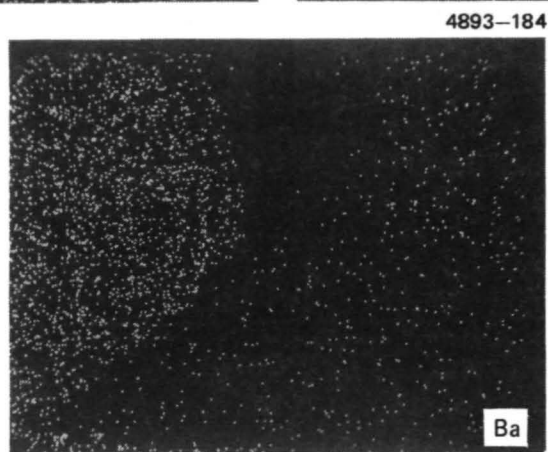
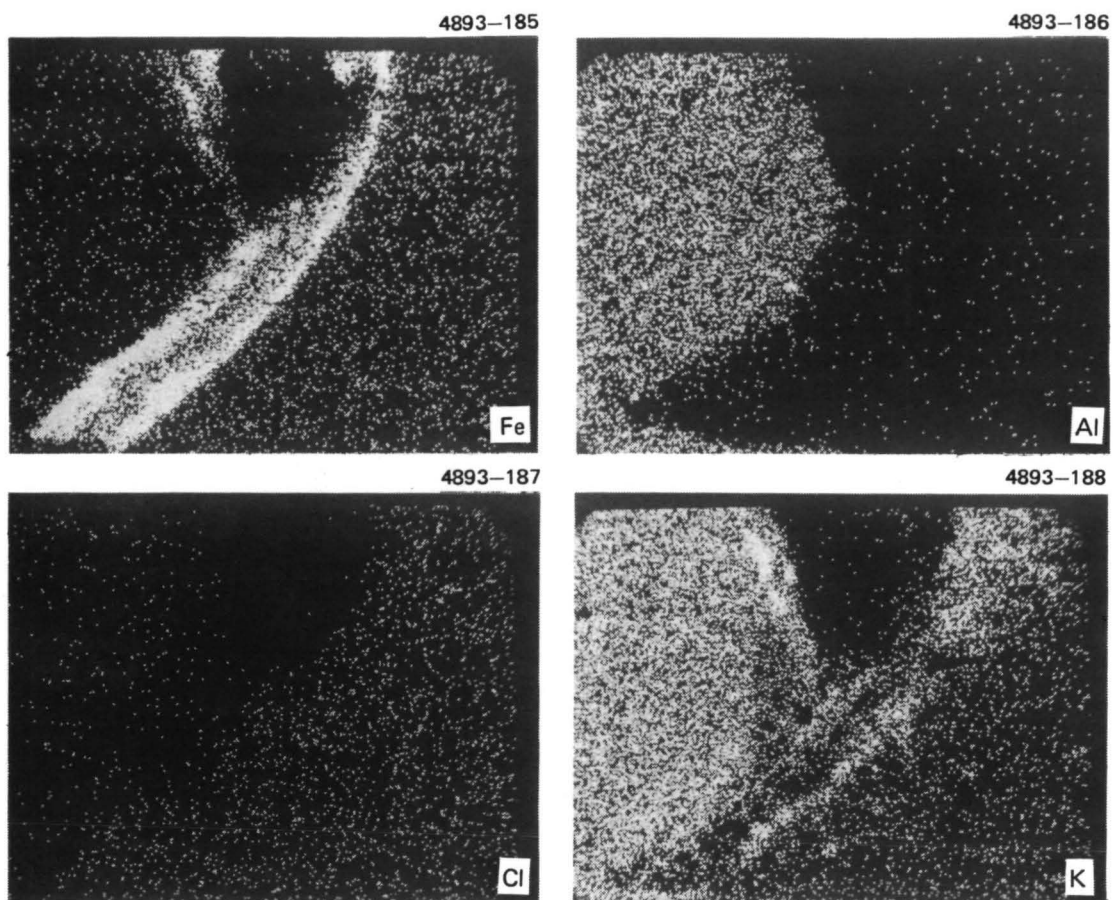
Figure A-90. Microscope photo, SEM photo, and E-beam microprobe analysis of screen electrode downstream coating.

- Coating formation on the screen grid electrode (downstream side) may require special surface treatment of the electrode.

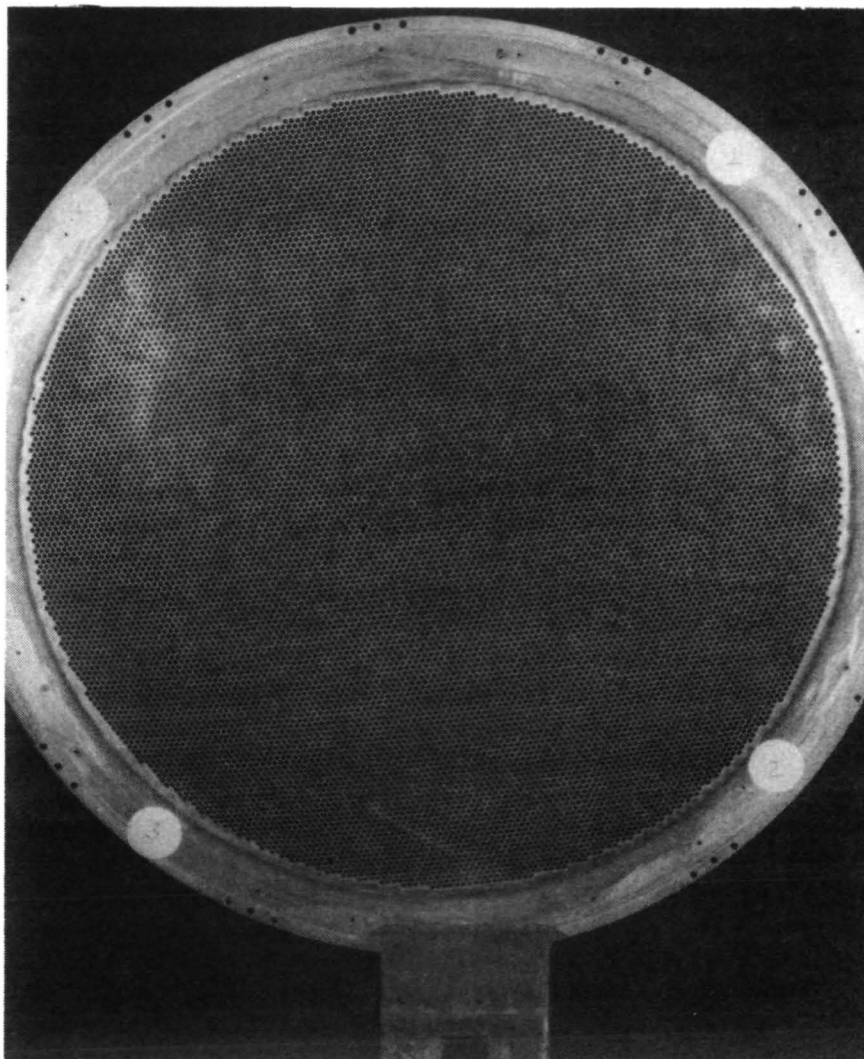
Figure A-91. Screen electrode, downstream side.

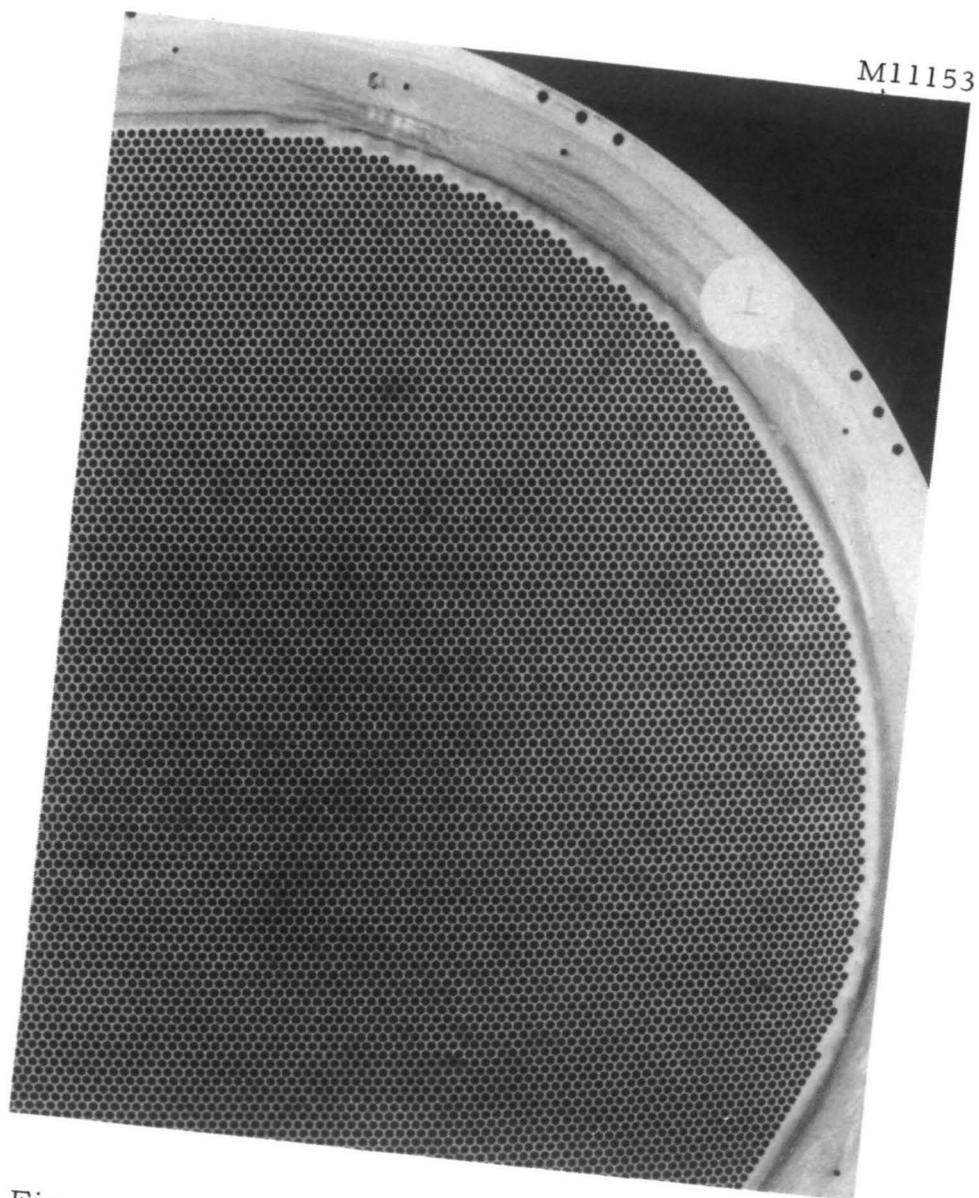
Figure A-92. Screen electrode, downstream side.

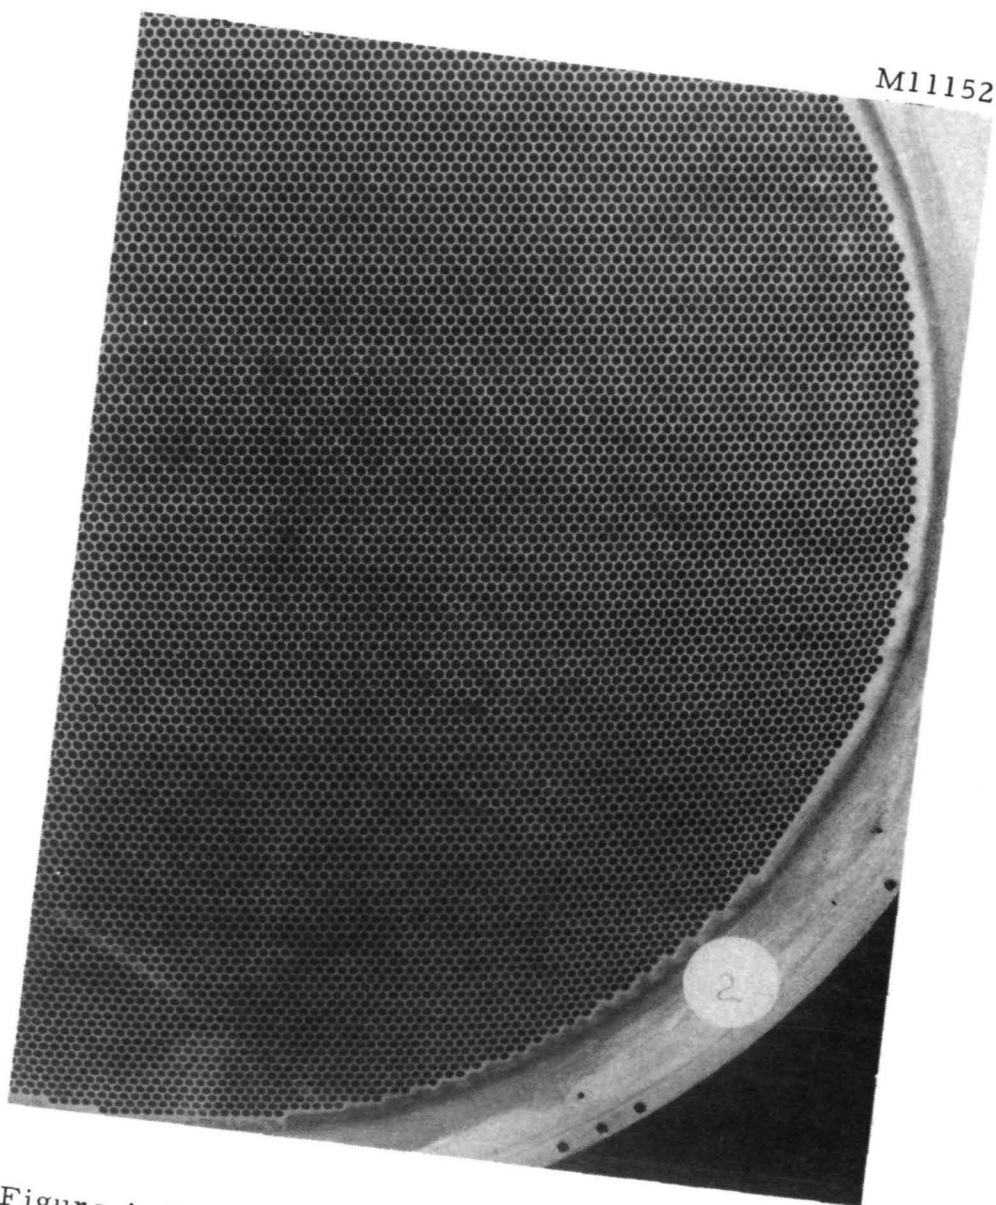
Figure A-93. Screen electrode, downstream side.

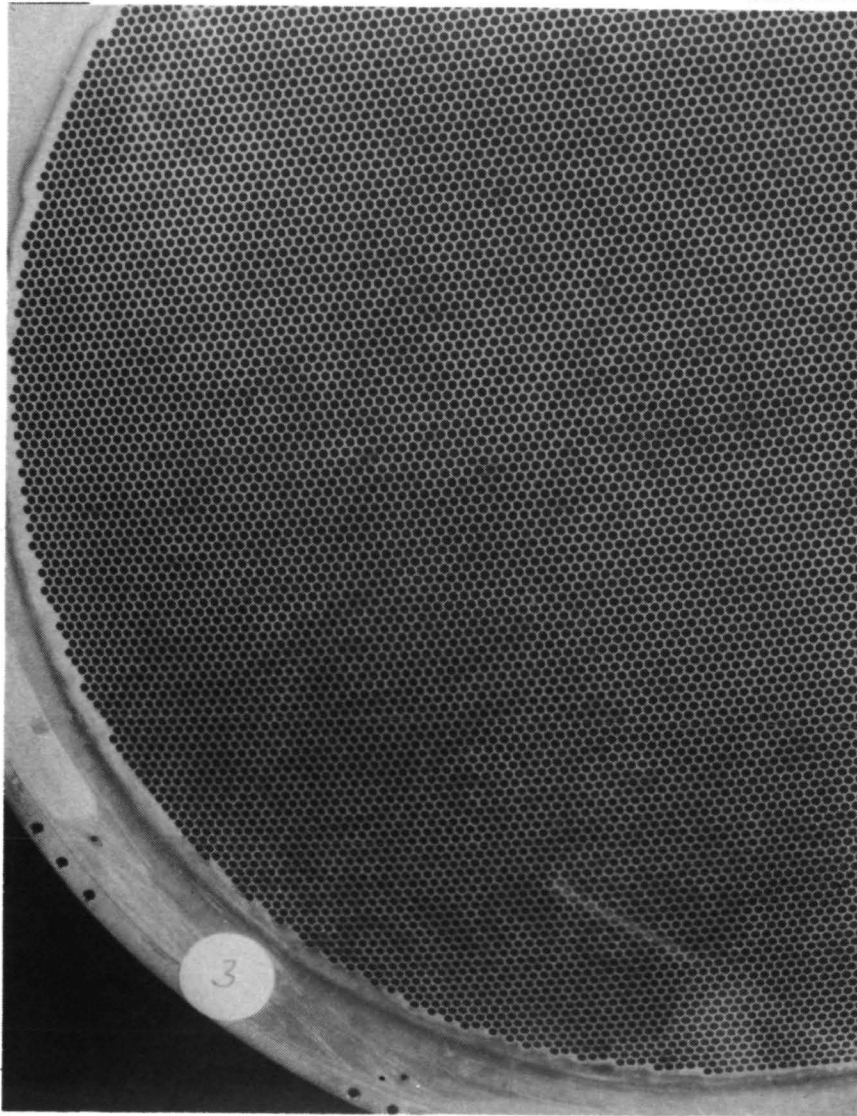
Figure A-94. Screen electrode, downstream side.

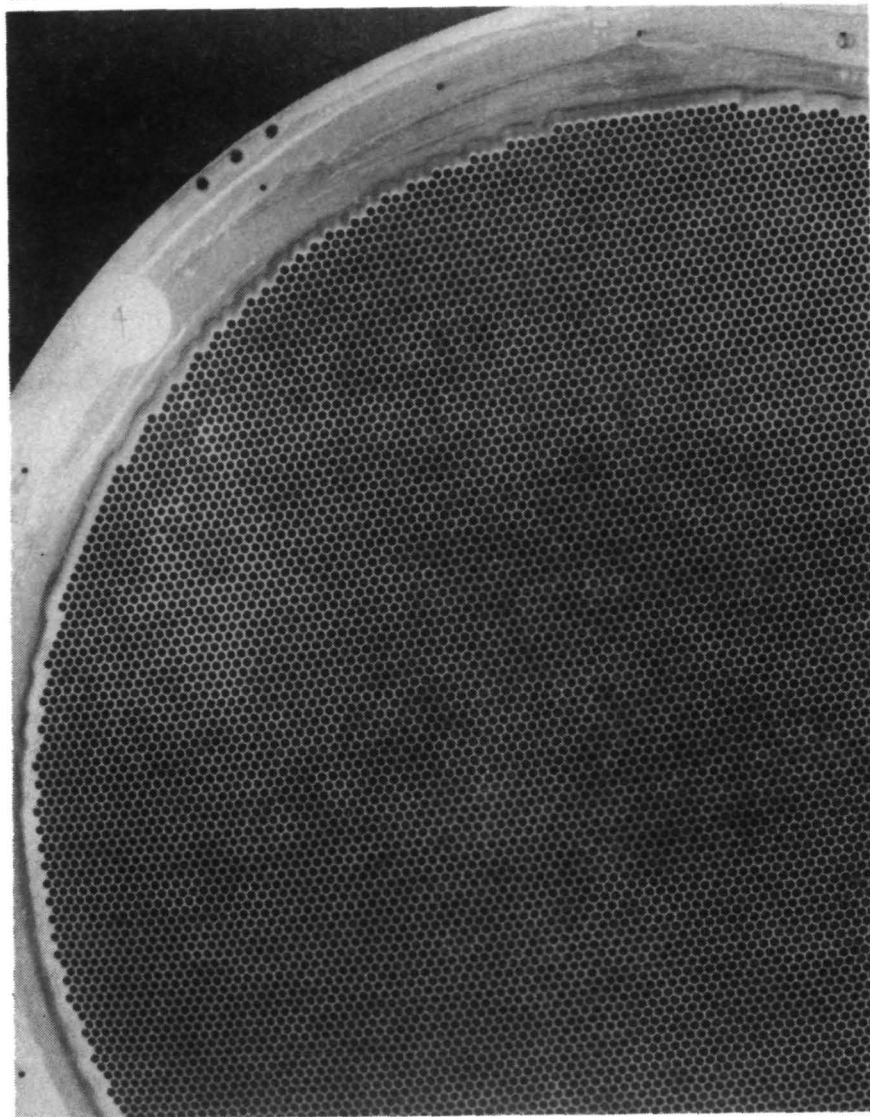
Figure A-95. Screen electrode, downstream side.
